LEADED LIGHT WINDOW DETAILS

ISSUED FOR TENDER

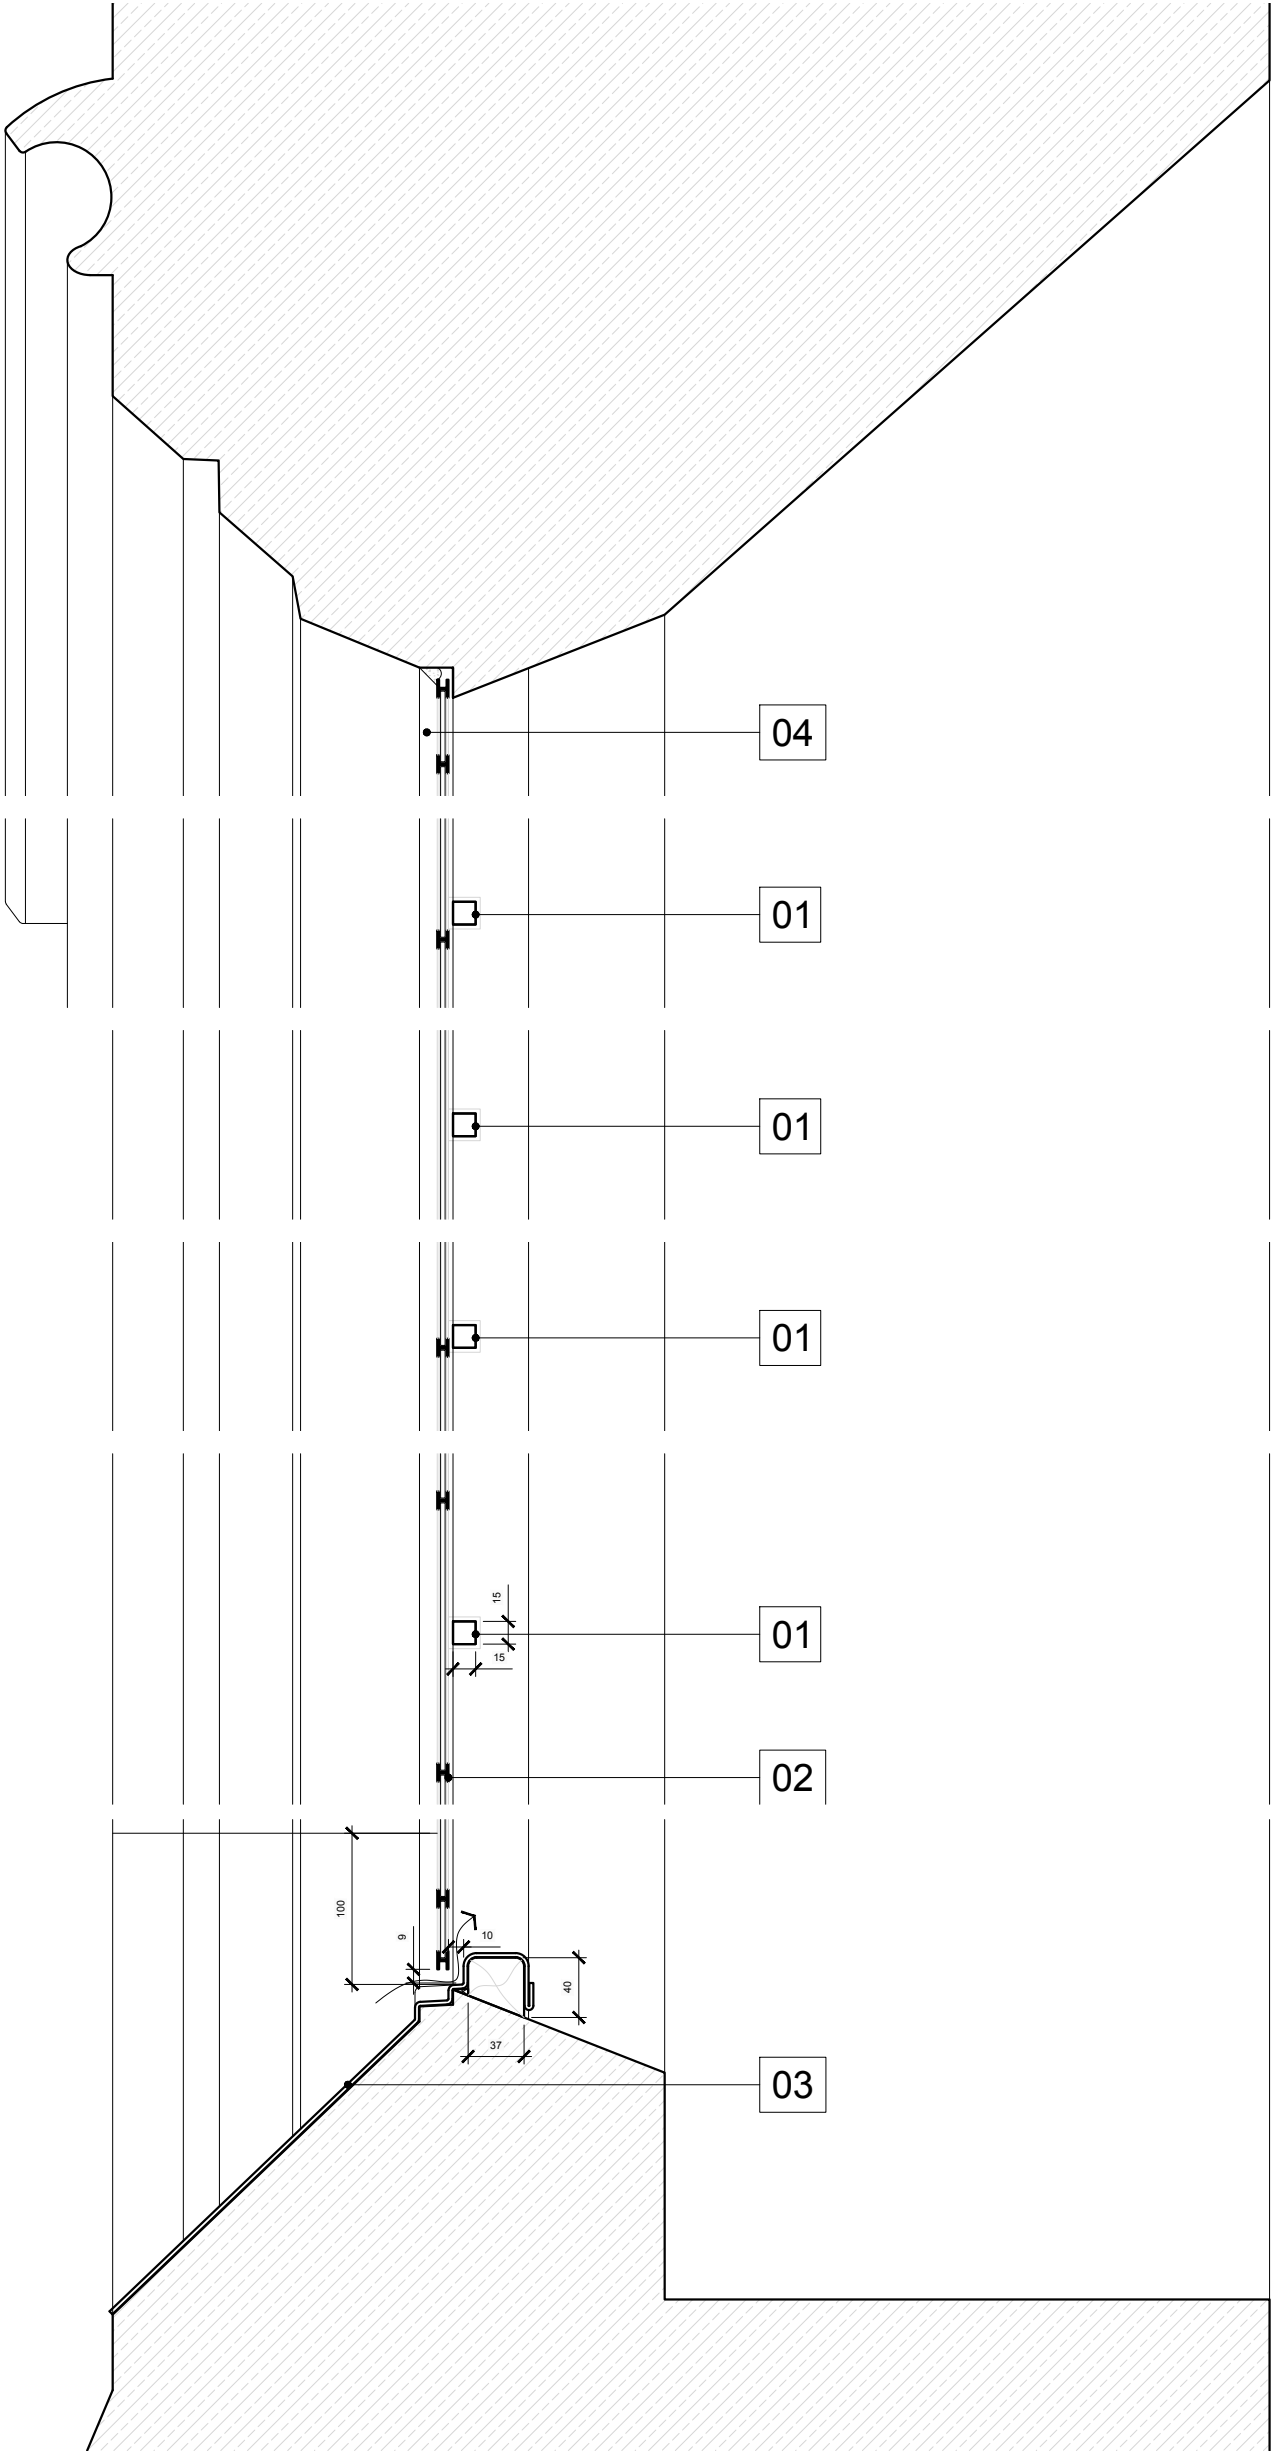
1  
(40)02

1) L40: Existing 15mm square saddle bars to be carefully removed from the existing opening and stainless steel tip to be installed to the bar ends. Bars to primed and decorated as M60, re-set and repointed as Z21.

2) L40: New diamond leaded light panels by a specialist glazier to be set in 6mm wide round profile lattice of lead comes with a 16mm wide border. Lead panels are to b secured to the saddle bars using lead or copper ties.

3) H71: Code 6 lead tray to be formed to the base of the window allowing for 10mm continuous ventilation to the underside of the window. Lead trays to be fixed to a new continuous ex. 45 x 45mm kiln dried oak fillet, cut to suit the sloping cill internally.

4) Z21: Lime pointing of leaded light panels externally is to be undertaken by stonemasons and not the glaziers.
